Repair of Panel N39 and Placement of Geotextile and Armor Stone in Panels N37, N38, and N39

PREPARED FOR: demaximis, inc.

PREPARED BY: George Hicks, CH2M HILL

DATE: April 14, 2014

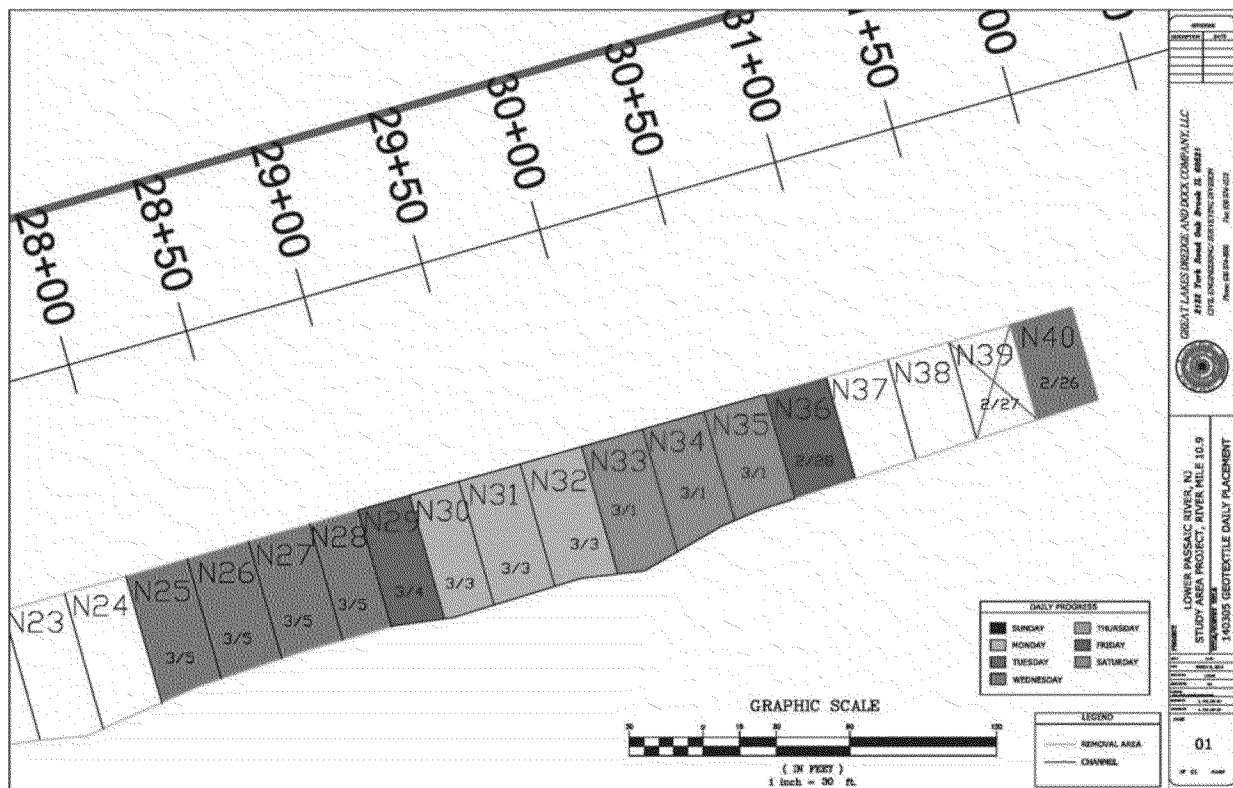
Figure 1

During placement of geotextile panel N39 on the northern end of the cap area (Figure 1), the geotextile panel and armor stone placed on top of the geotextile slid down the slope. Subsequently, the geotextile/armor stone which accumulated at the bottom of the slope was removed on March 31, 2014. The following sections outline the proposed means and methods to repair the N39 area and place geotextile and armor stone in uncompleted panels N39, N38, and N37.

The root cause of the panel N39 instability has not been definitively determined. The operating assumption is that the geotextile was inadequately anchored to at the shore, and subsequent placement of rock further down the slope caused the panel to pull away from the shoreline.

The active cap layer (Sand/AquaGate) in the panel N39 area will be repaired by placing Sand/AquaGate cap material (as necessary) to meet the thickness requirements within the N39 area. A bathymetric survey of panel N39 showed an area at station 31+60 (center of panel N39) where some of the cap material was scoured during the failure. Cap materials (Sand/AquaGate) will be added to these low areas using the material handler, equipped with RTK GPS positioning system. This positioning system will be used to place the cap material as required to meet the minimum cap thickness of 8 inches. The cap material will consist of a ~30% (v/v) Aquagate and ~70% (v/v) sand mixture. This mixture will be prepared by adding one bucket of aquagate to two buckets of sand and then blending the materials to obtain a well-blended mixture.

To anchor the geotextile on shore, the geotextile fabric will be extended up onto the existing rip rap layer along the shore and additional armor stone will be placed on top of the geotextile to hold it in place. Once the geotextile panel is anchored the panel will be lightly armored from the shore to the leading edge of the geotextile panel. Once the geotextile panel is fully extended, the final thickness of armor stone will be added by placing the stone from the base and working back up the slope towards shore. This placement method is intended to provide a stable base for the remaining armor stone to prevent it from rolling down the slope.
